Site Inspection Report (Phase I Investigation)

TEXAS INSTRUMENTS, INC.
Attleboro, Massachusetts

November 1985

MDEQE Project Number 86-01-54-14
WE Project Number 02365276.054A-01

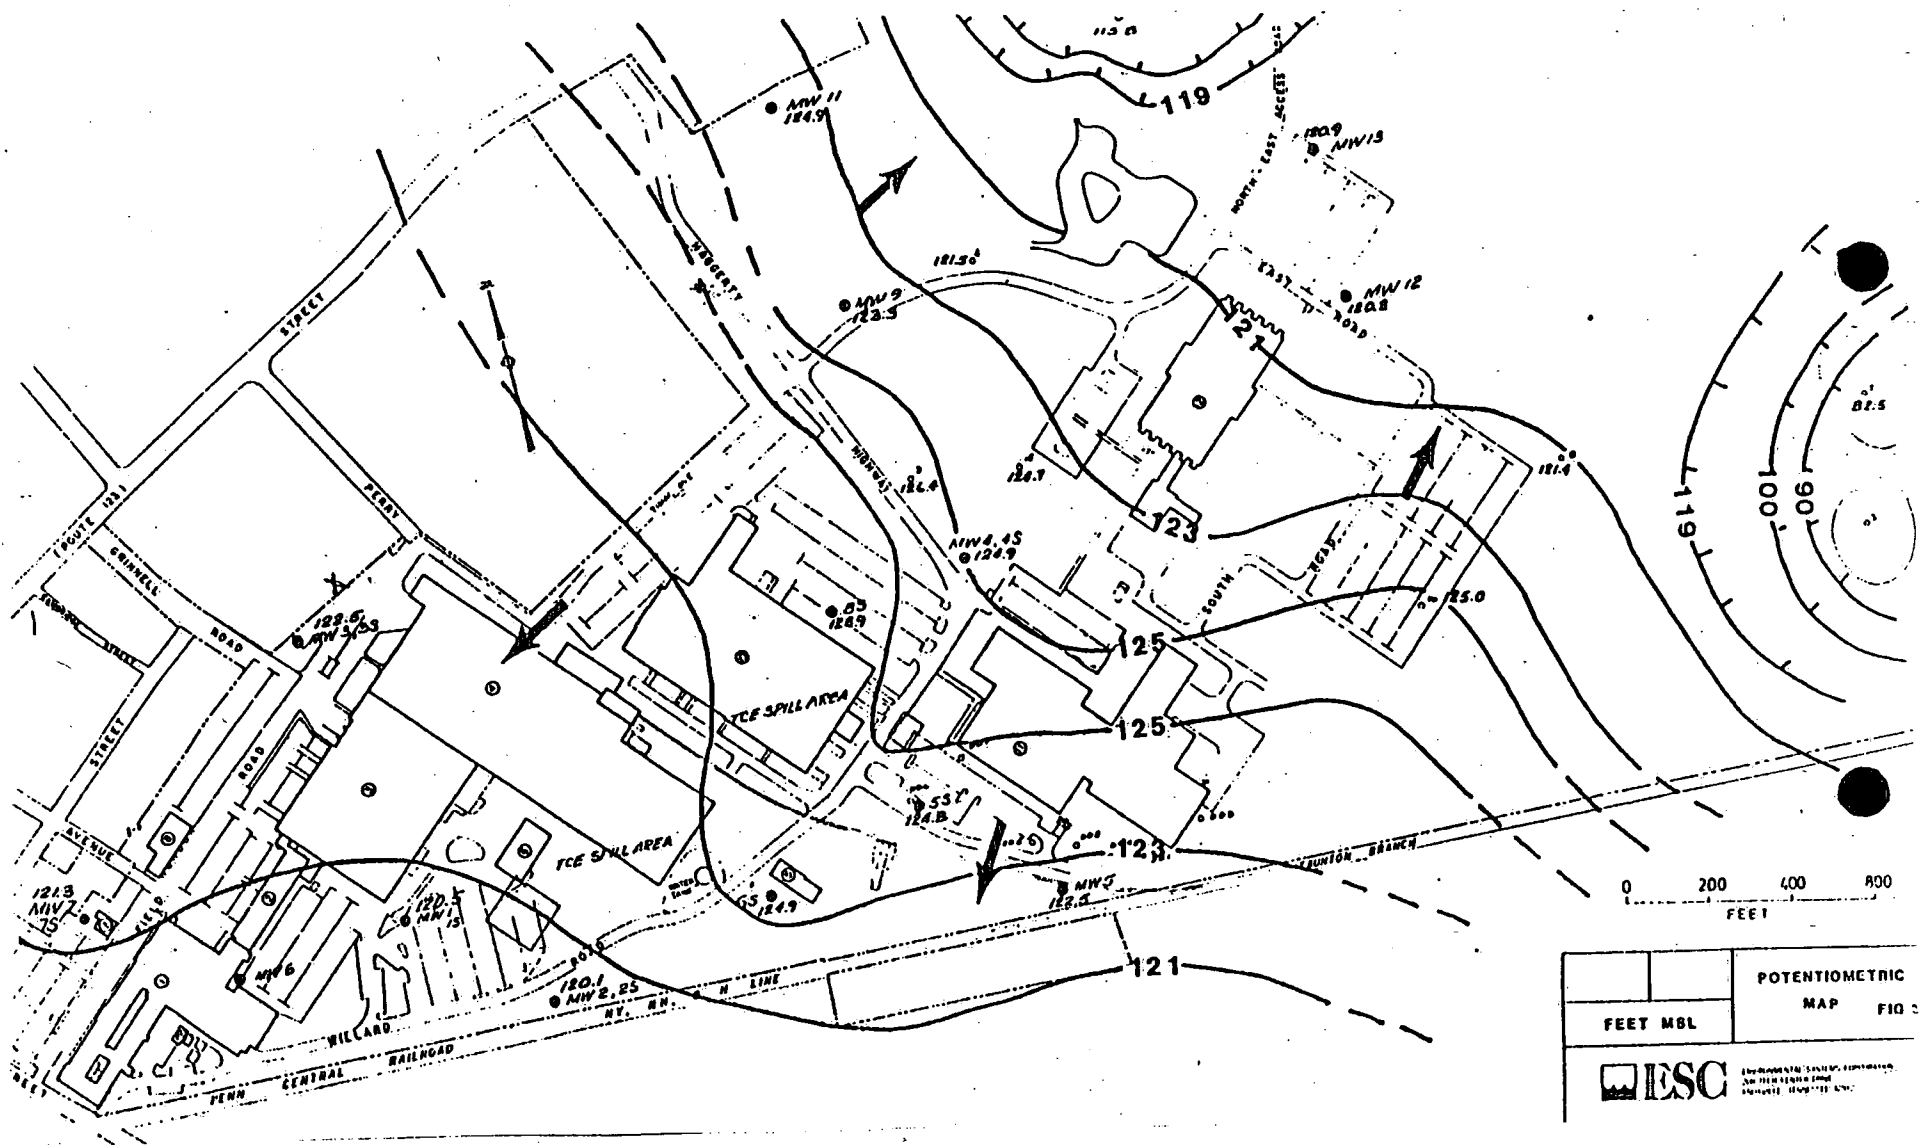
Figure 4-1 Potentiometric Surface Map (ESC, 1984)

A site groundwater table map for the overburden aquifer (reproduced from reference 3) is presented on Figure 4-1. The map shows a

groundwater divide near Building 11 and northeast of Building 10. From this divide, water flows both northeast and southwest. According to Reference 3, the groundwater divide in the bedrock aquifer is centered near Building 10. The bedrock groundwater flow directions are described as being similar to the overburden aquifer flow directions. Texas Instruments has production wells in the bedrock aquifer in the northern and eastern area of the site and these wells may exert an influence on the groundwater flow direction.

East of the groundwater divide, the vertical distance between the piezometric surface in the bedrock and the overburden reaches 4 feet (Ref. 3), indicating a downward vertical hydraulic gradient between the overburden aquifer and the bedrock aquifer. This suggests that the bedrock aquifer may be recharged by the shallow overburden aquifer. The area west of the surface water divide is described to show little head difference between the overburden and the bedrock aquifer water levels. There are no production wells west of the groundwater divide.

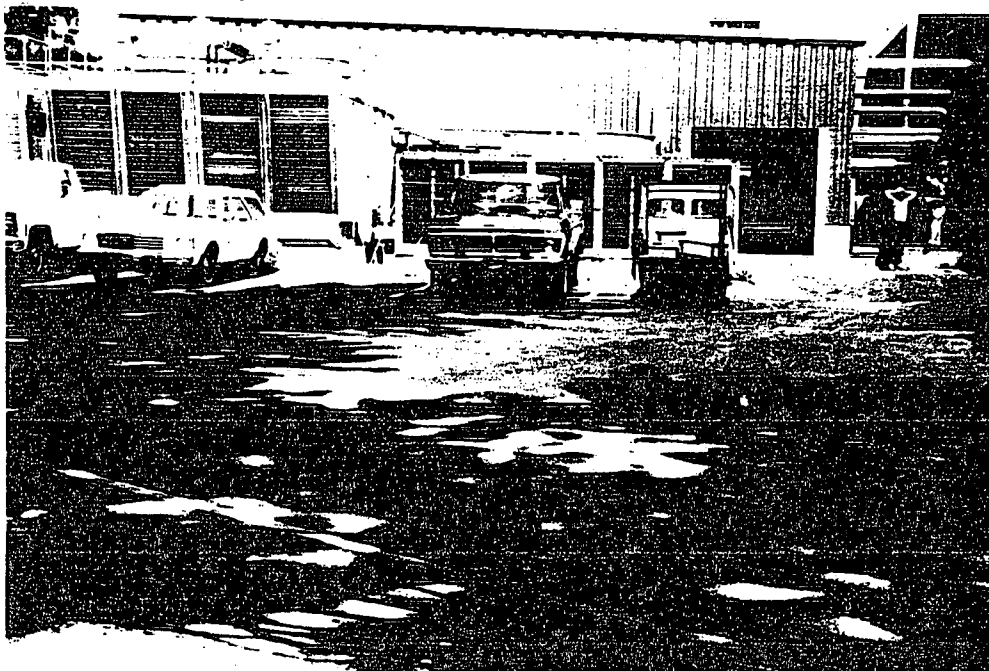
Photograph #1: Surface Discharge (001) to Speedway Brook (Grating in Road, Building No. 1 in Background).

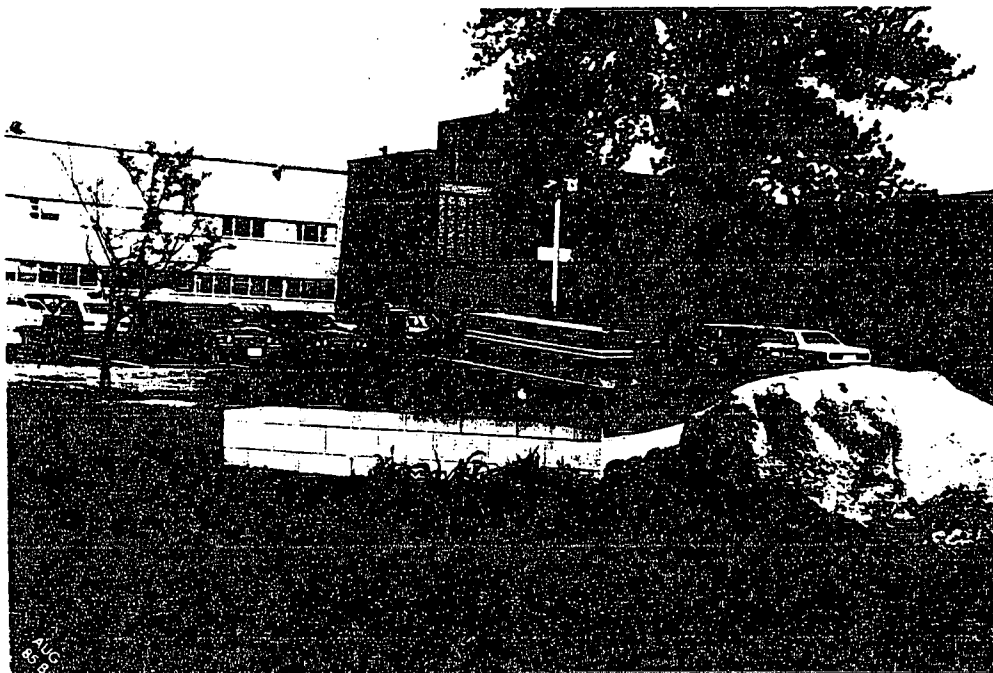
Photograph #3: Oil/Water separator in foreground, water goes towards Surface Discharge- 002 (Building Nos. 3 and 4 in background).

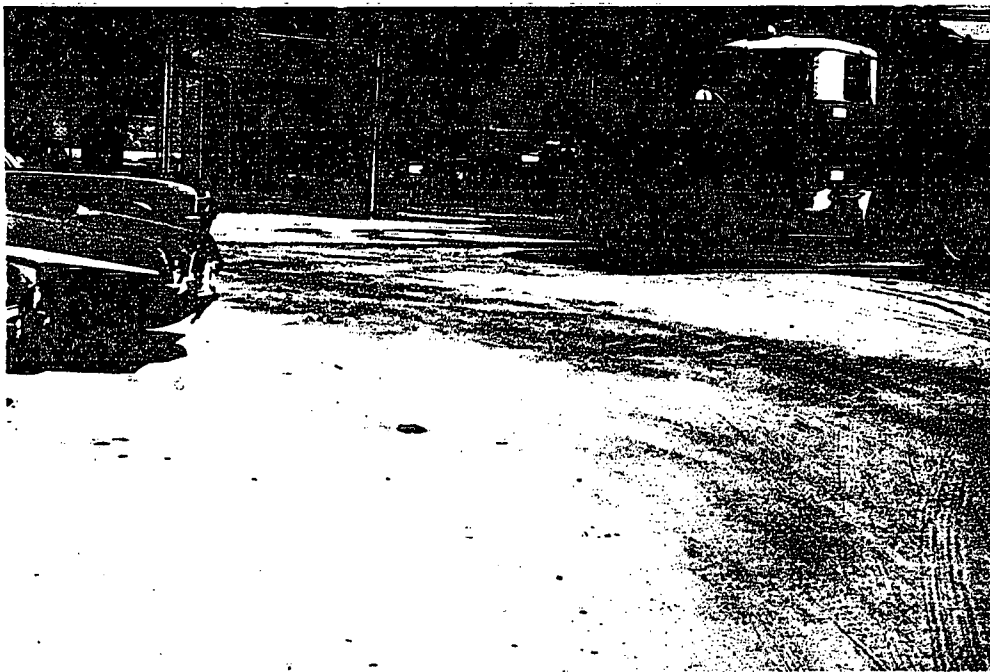
Photograph #5: Location of old underground fuel oil tank. Tank has been emptied and filled with sand (looking towards Building No. 4).

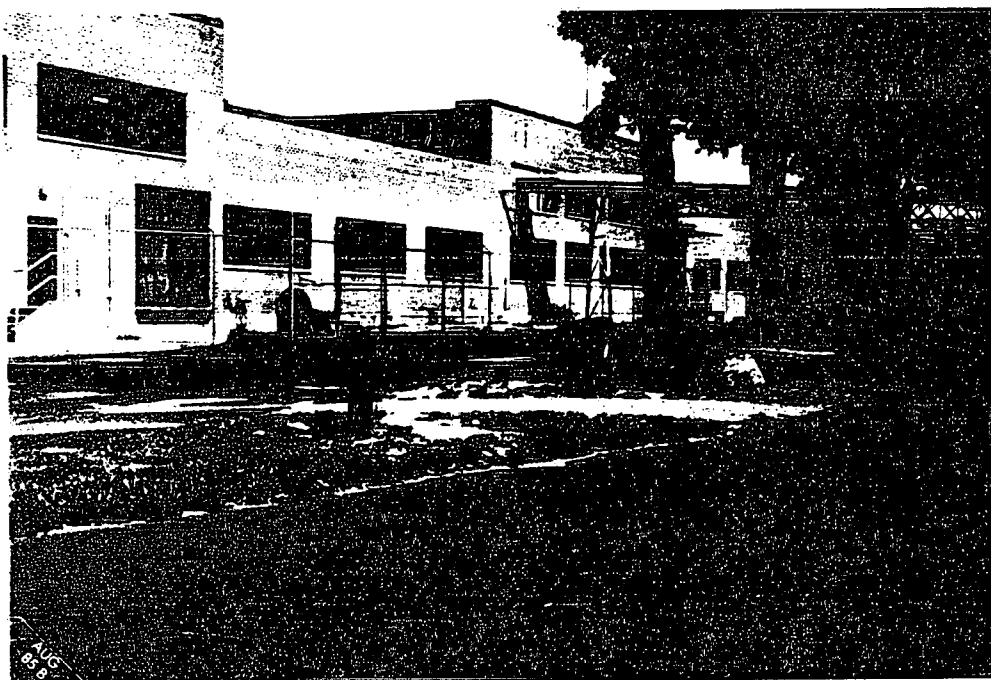
Photograph #6: Monitoring Wells 1 and 1s, Building No. 3 in background (Note: small white pipes behind furthest well in front of larger rock, are for Vadose Zone air monitoring). This is the possible location for a recovery well system installation.

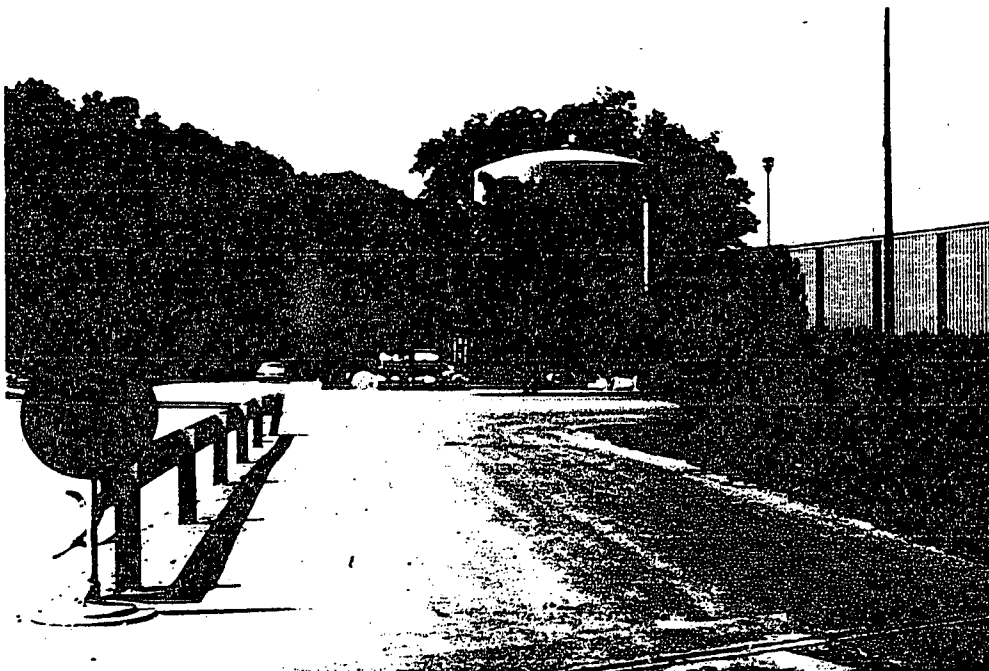
Photograph #7: Unsecured 55 gallon drums behind Building No. 4, water storage tank in background. (Red/white drums will contain precious metals waste, other drums will contain metal scraps).

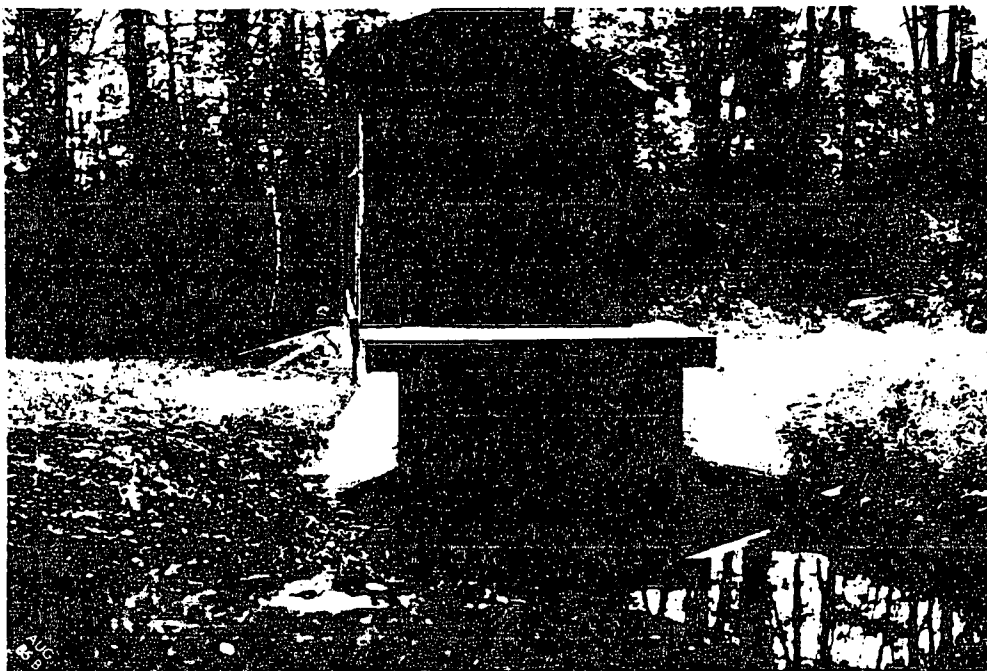
Photograph #9: Automatic water sampler shed located along creek before water reaches New Duck Pond (from surface discharge-005).

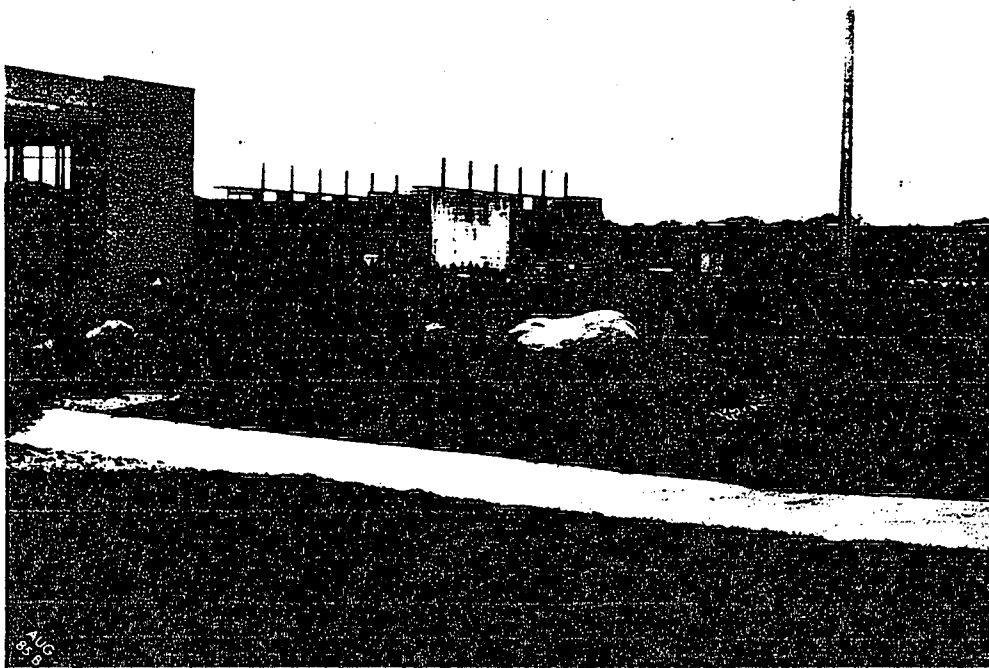
A pit used to dispose of equipment contaminated by low-level radioactivity (located east of Building 10), was covered some time during the 1970s. Previously contaminated soil may also have been disposed of in this area. During the 1970s, when a buried pipeline was laid through the disposal area, buried contaminated machinery and metallic parts were removed. This location is referred to as the NRC disposal area, and four (4) NRC monitoring wells have been installed to monitor groundwater conditions near the disposal pit.

Photograph #13: The northern portion of the old NRC Disposal Area (Building No. 12 on left-hand side, Building No. 11 in background, looking southeast).

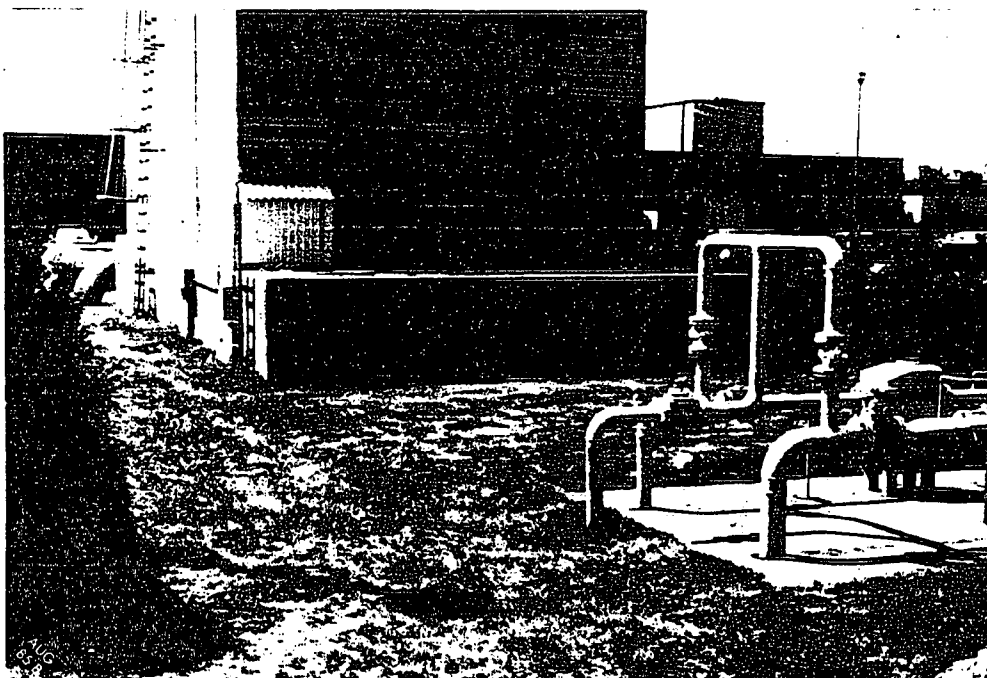
Photograph #14: Surface Discharge (004) from cooling towers, outlet is underground (Building No. 11 in background, Building No. 10 in far right side).

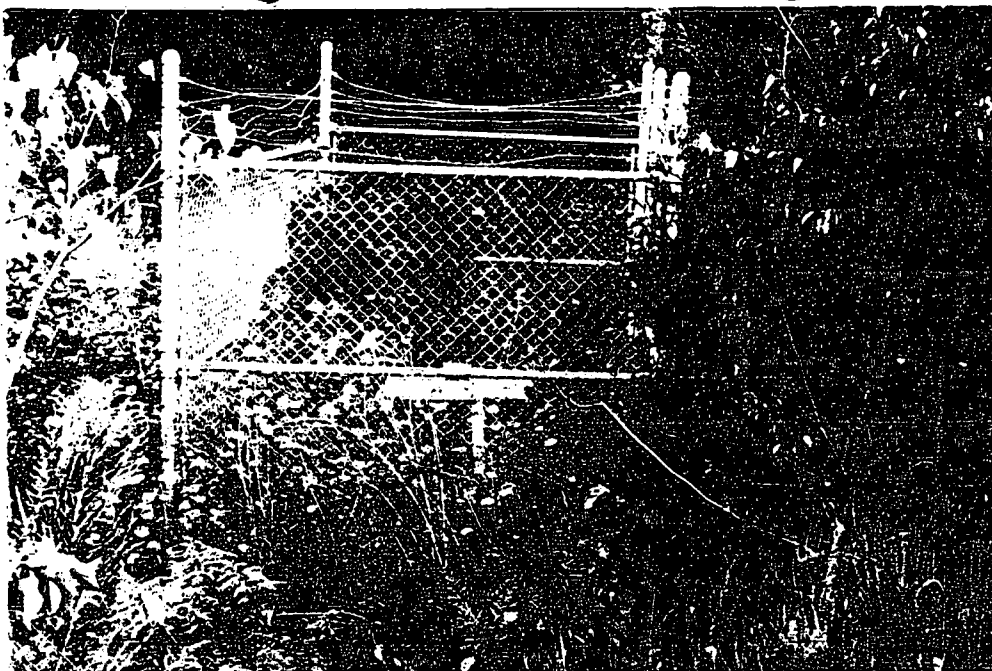
Photograph #15: Surface Discharge (004) Water Sampling station, automatic sampler no longer used (eastern corner of parking lot, looking east away from Building No. 12).

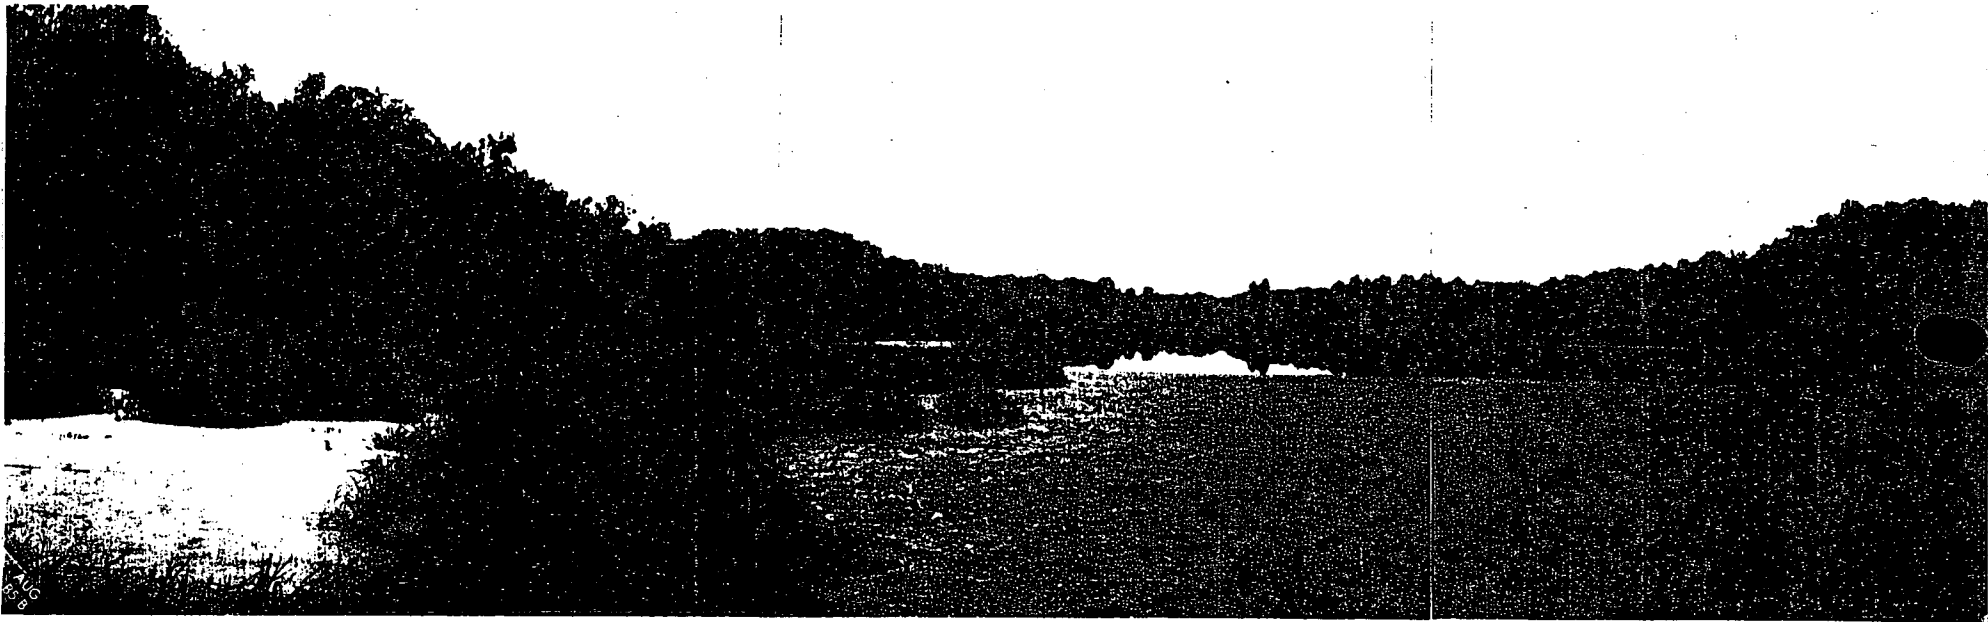
Cooper's Pond has previously been described as highly eutrophic, containing colored and turbid water, covered at times with duckweed and filamentous algae. A biological study of Cooper's Pond showed a reduced fauna compared to the Wading Pond control station. Also, only pollution-tolerant taxa were found downstream of Cooper's Pond by Massachusetts DEQE in August 1984.

Photographs #16, 17, 18: Panoramic view of Cooper's Pond, looking northwest, showing duck weed and filamentous algae floating on top of water.

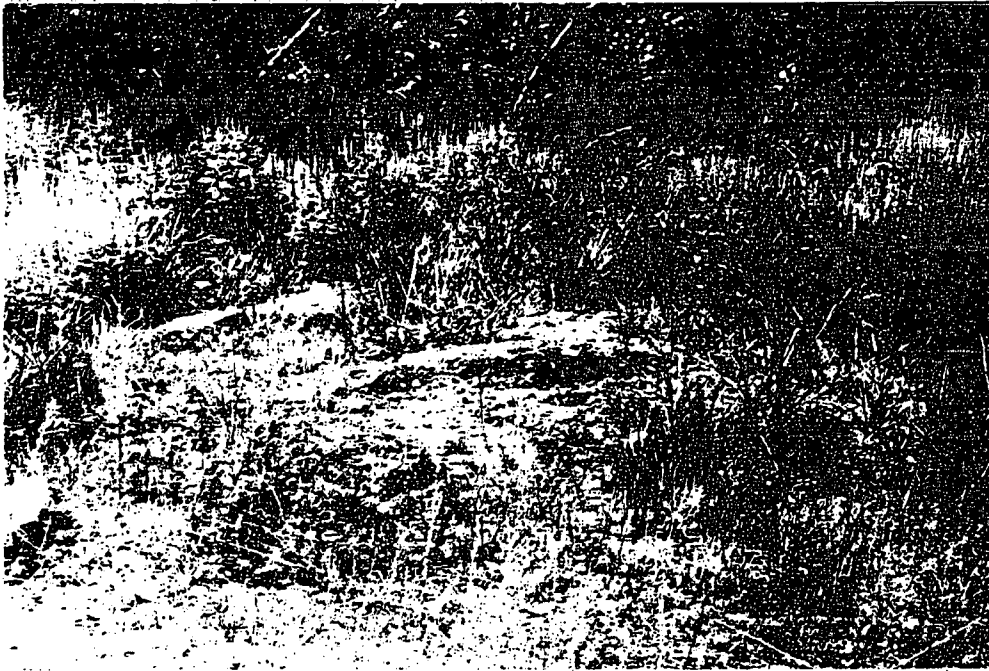
1. Discolored soil was noted along service road between new ballfield and monitoring well No. T-7 (soil had unusual dark red/maroon coloring).

Photograph #23: Discolored soil (red to maroon color) alongside of dirt road between athletic ball field and pumping well T-7 (looking north).
